RE: RCRA Notice of Violation
Wolverine Advanced Materials
VAD065408692

INSPECTION REPORT

WOLVERINE ADVANCED MATERIALS
Blacksburg Facility

May 7, 2014

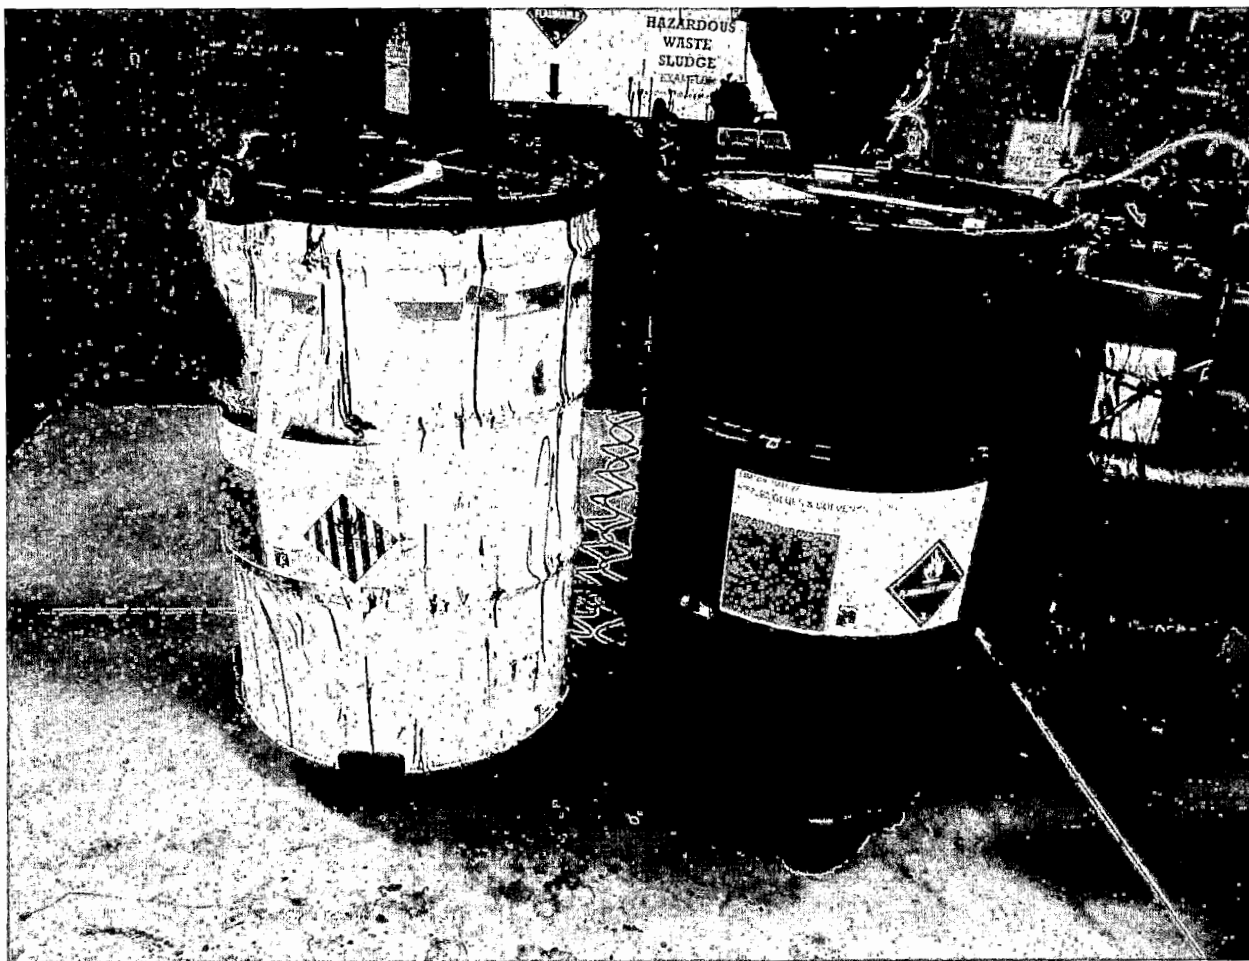
The inspectors walked the productions line observing the satellite accumulation areas at point the equipment cleaned (Photo #1). At two different location the small bung in the waste solvent drum was removed (Photo #2). All the satellite drums observed were properly labeled.

Photo #1 - Satellite are in the process area. Drum on left is for solid hazardous waste (debris) and the drum in the middle is for hazardous waste liquids. The drum on the right is the clean solvent used to clean the rubber application equipment.

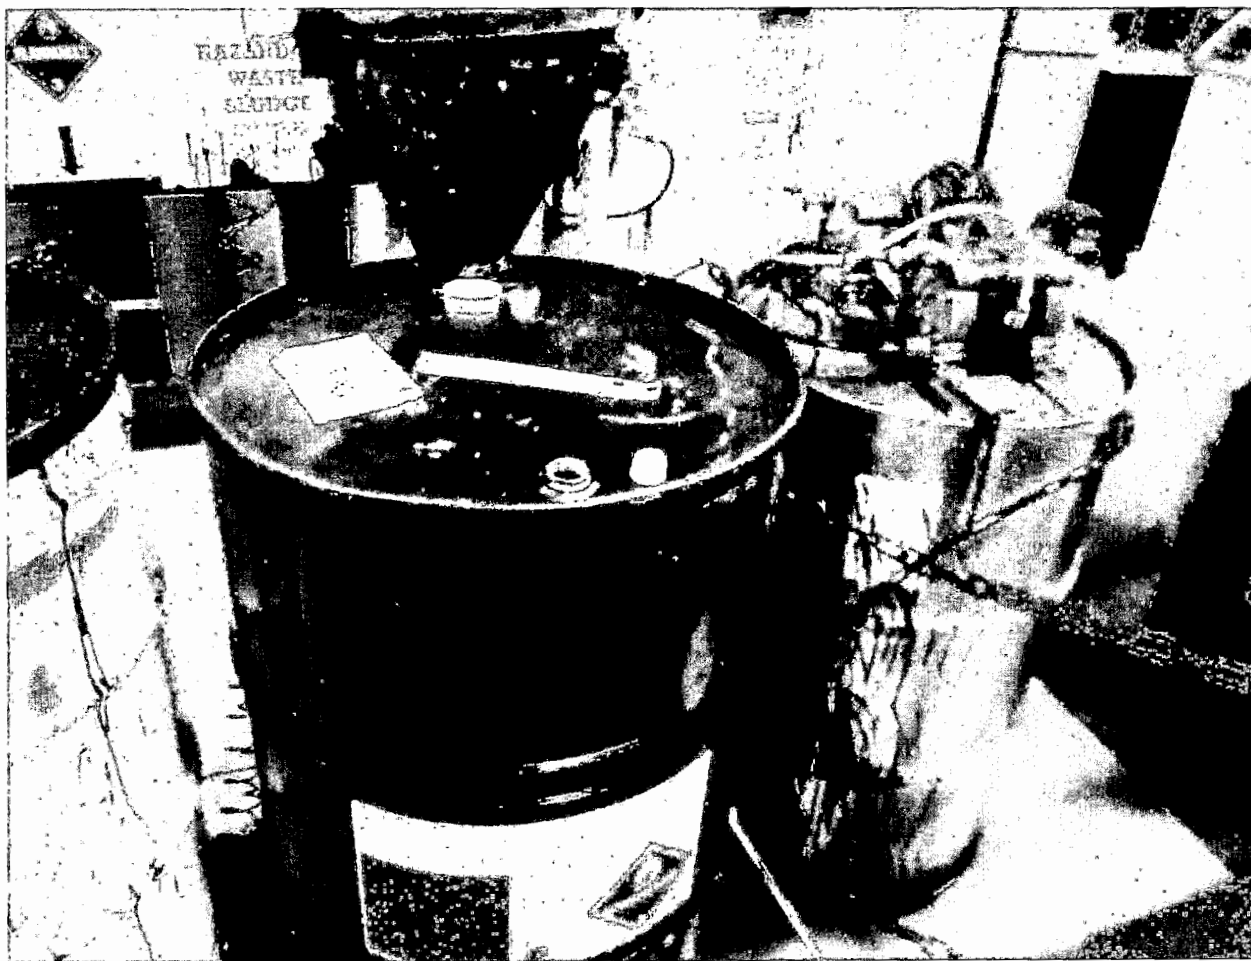
Photo #2 – Satellite drum in Photo #1 with small bung removed.

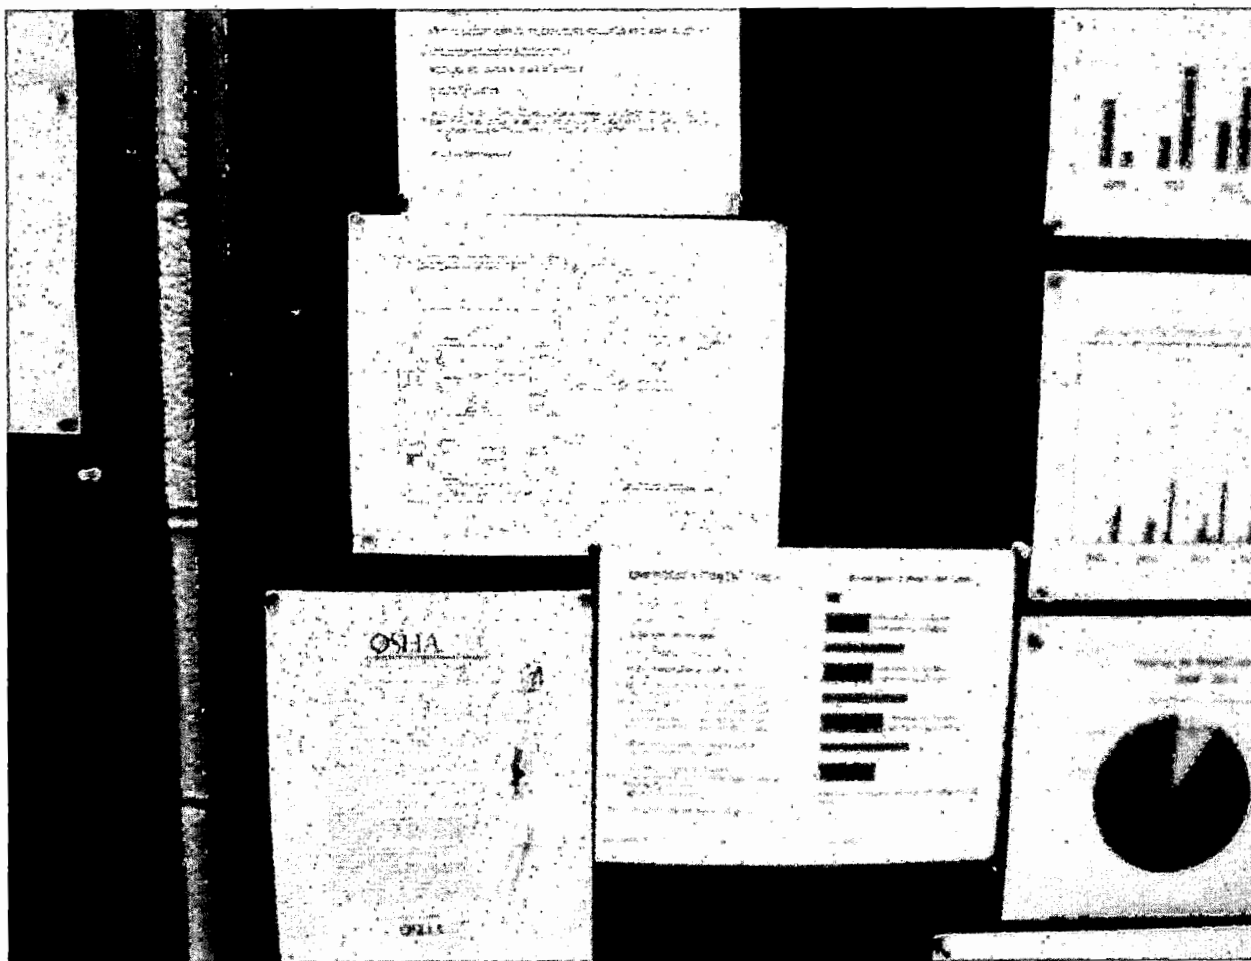
Photo #4 – Emergency information posted in the process area.

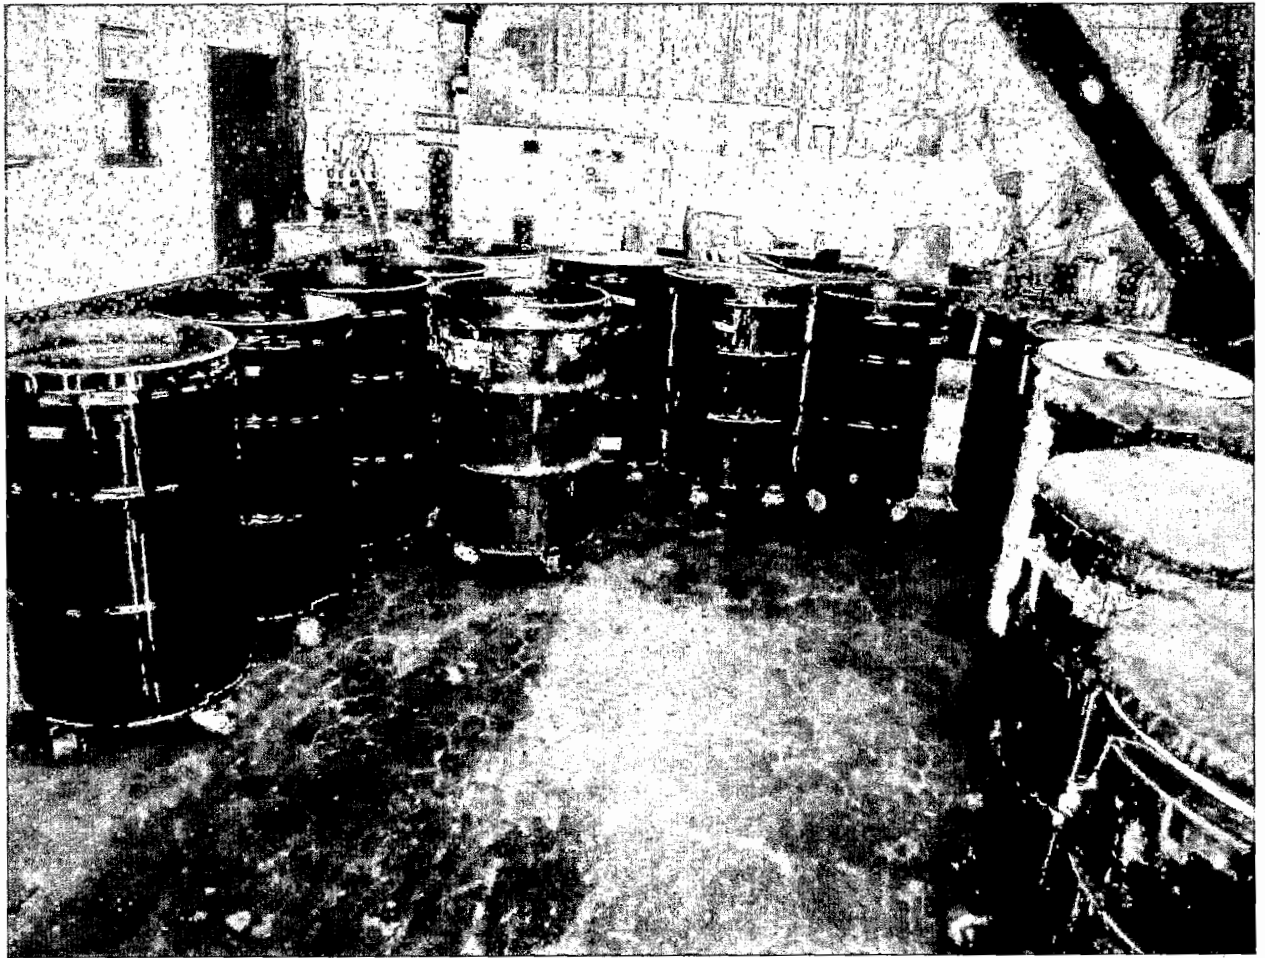
Next the inspector went to the prep area (Photo #6) where partially full satellite drums are brought to be combined into full containers prior to moving to the 90 day storage area. There was one open drum (Photo #7) that was about $\frac{3}{4}$ full. No one was working in the area at the time.

Photo #6 – Prep area where drums of waste are combined prior to being sent to 90 day storage area. The covered drums on the right are holding rubber waiting to go to the process line.

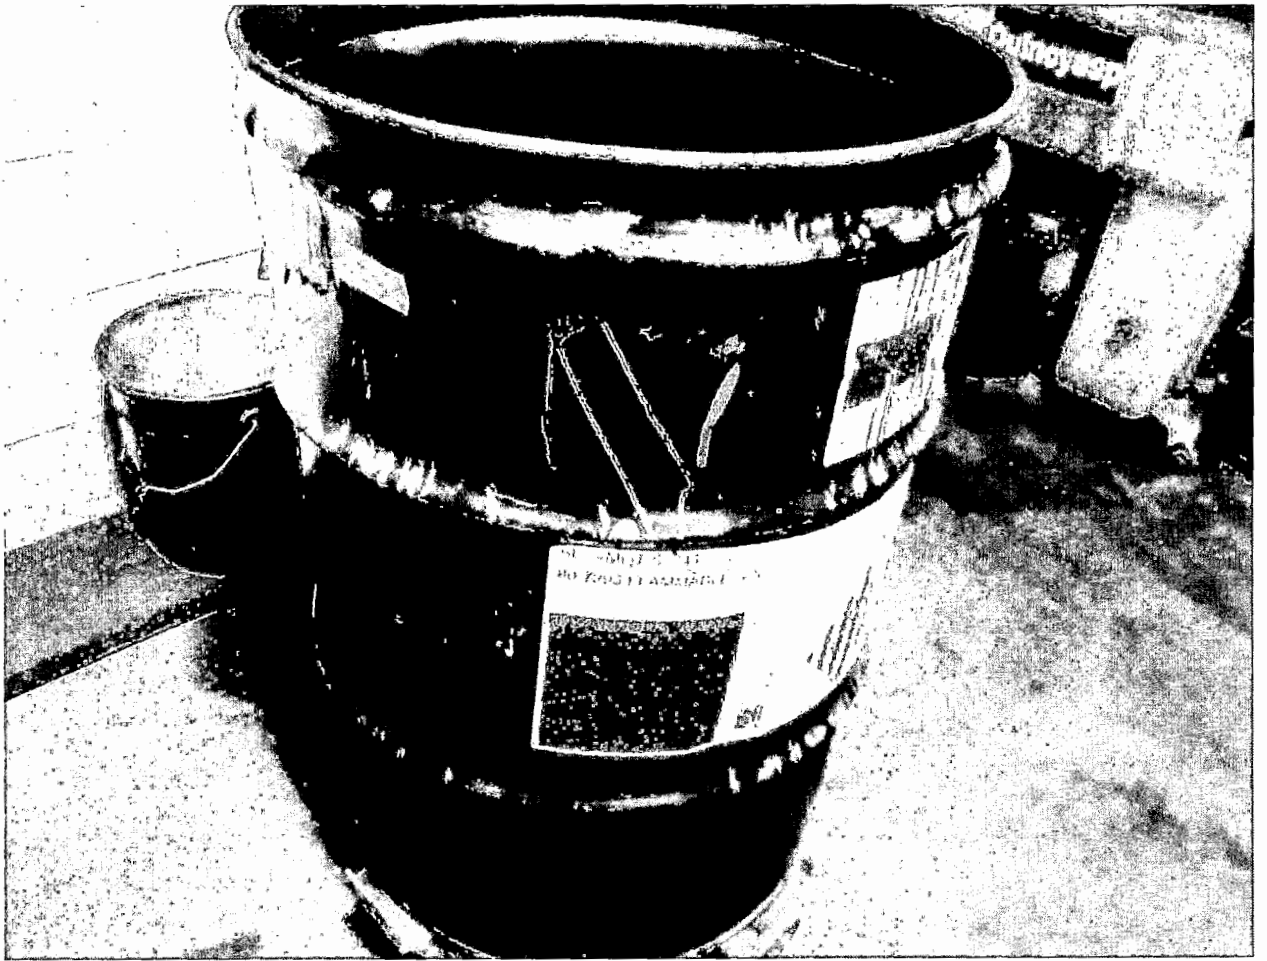
Photo #7 – Open drum of hazardous waste in the prep area. The drum was $\frac{3}{4}$ full.

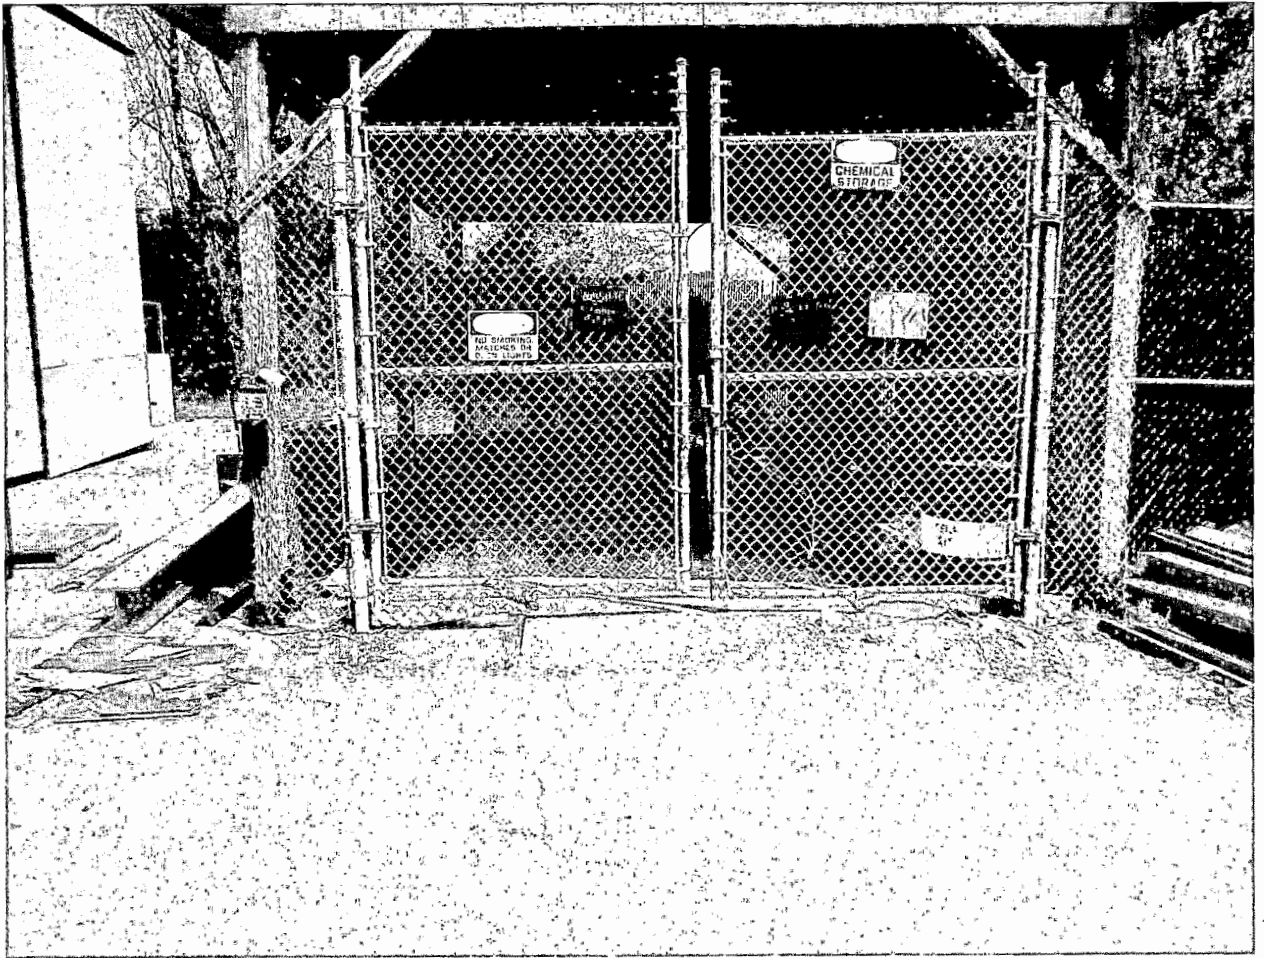
The inspector next observed the outdoor 90 day storage pad. There were four drums present, all dated within the last week. (Photos #8 & #9).

Photo #8 – 90 Day storage area.

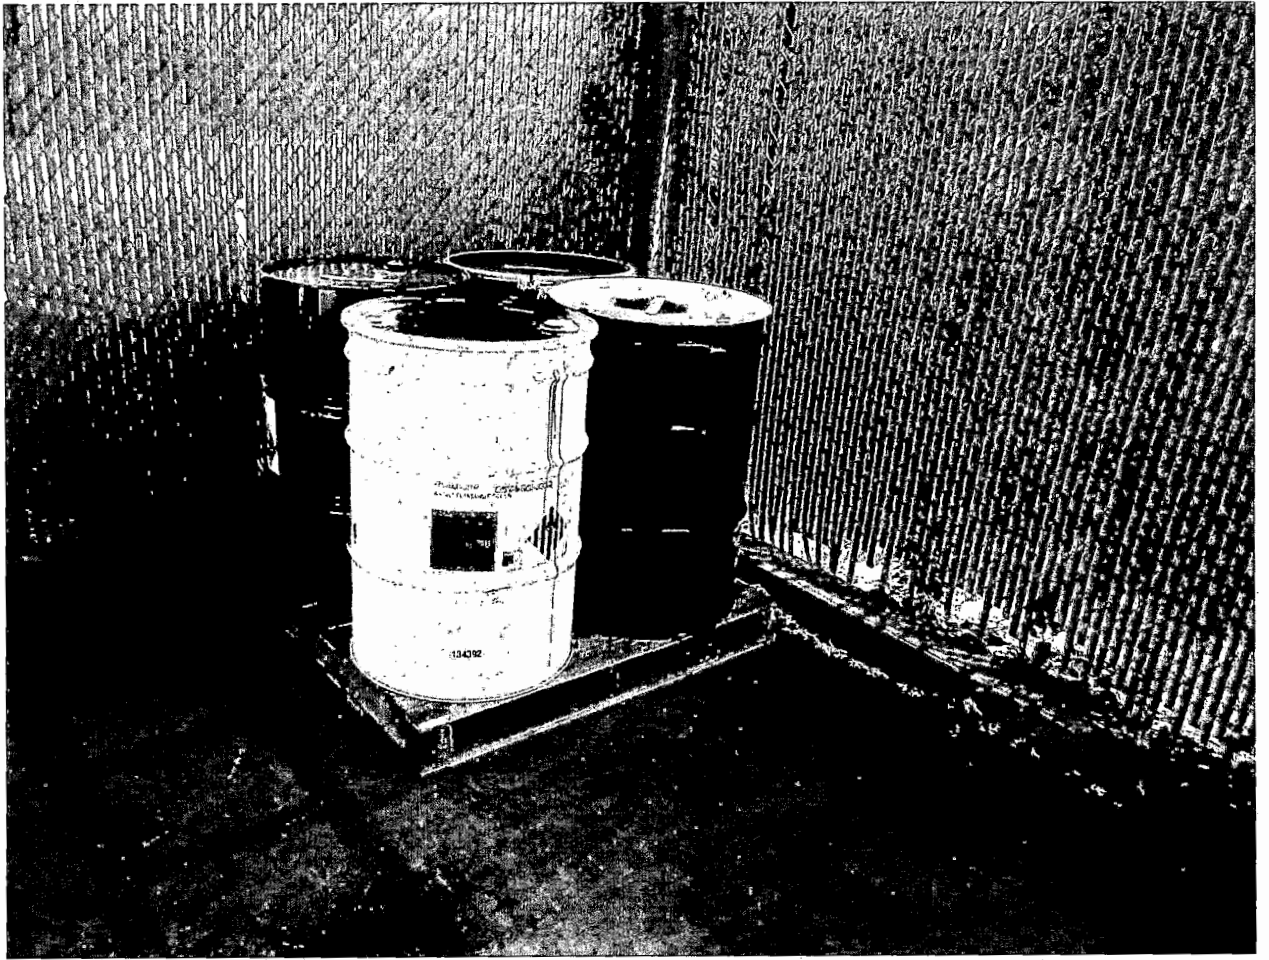
Photo #9 – Four drum on storage pad were closed, labeled, and dated between 5/4/14 and 5/6/14.

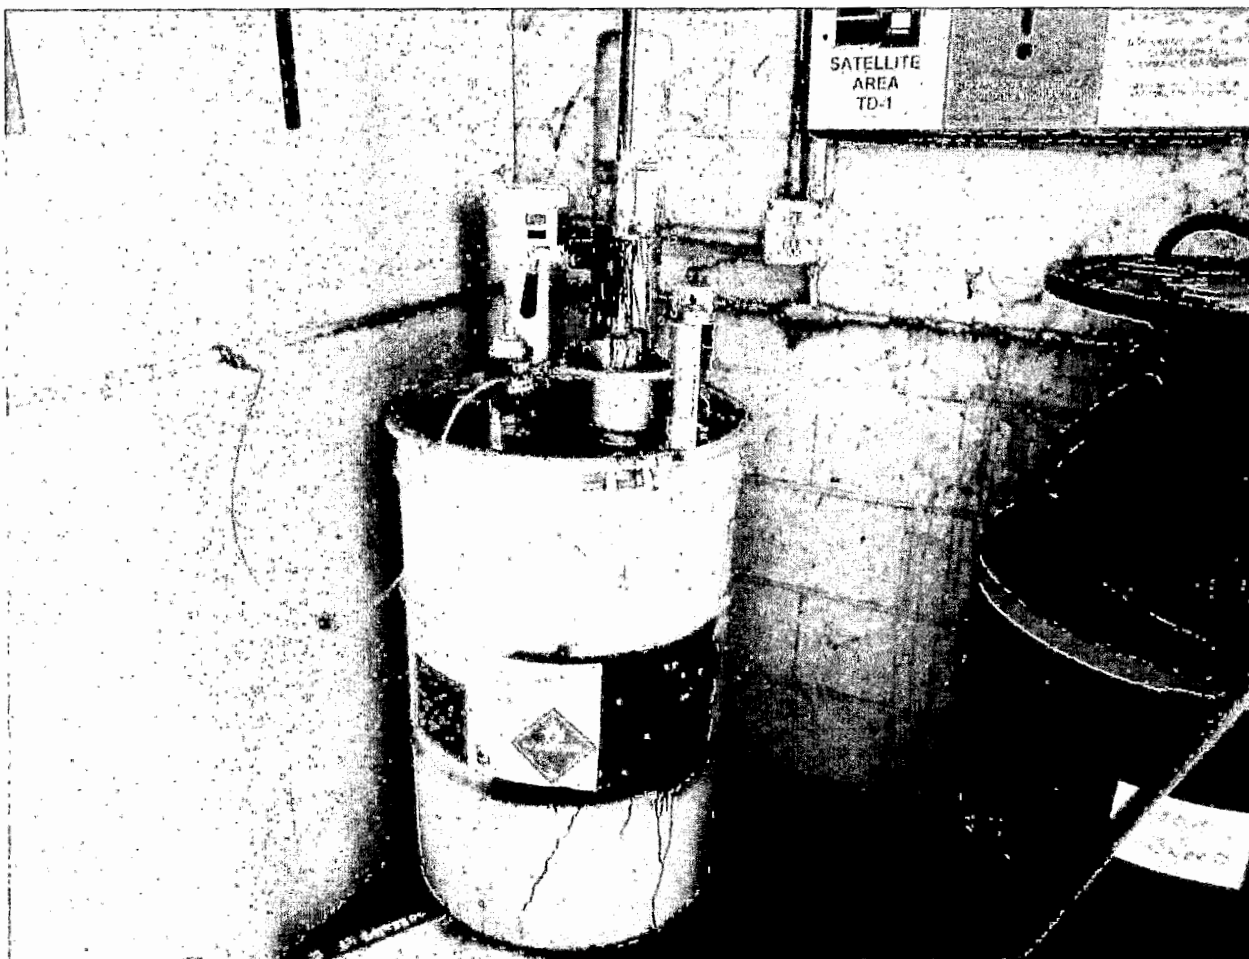
At the end of the plant tour we were taken to the location of the aerosol drum to puncturing device was located (Photo #10). The unit was closed and labeled hazardous waste.

Photo #10 – Aerosol can puncturing unit.

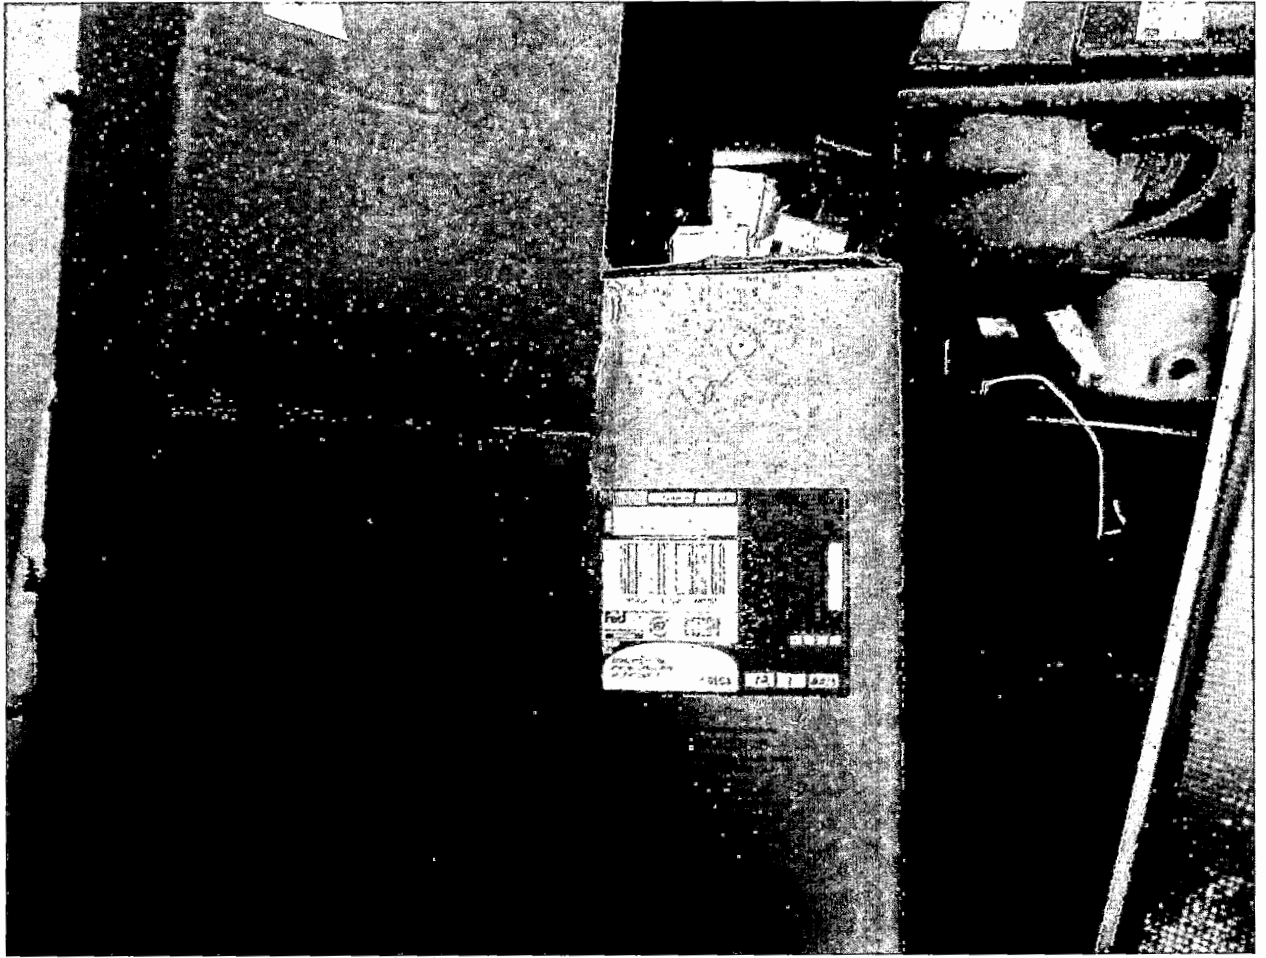
Spent fluorescent bulbs were observed uncontained or in an open box; however, all the bulbs were low mercury bulbs (Photo #3). The universal waste storage location was in a closet (Photos #11 - #14). There were two boxes labeled as universal waste that were closed and dated. There were three 12' bulbs the were not in a container, however they were low mercury bulbs.

Photo #11 – Universal waste bulbs stored in closed, labeled, and dated boxes.
